**Corrosion of stainless steels and of
corrosion resistant alloys in the
electric field induced by cathodic
protection systems**

Local corrosion of passive metal under the attack of external anodic current

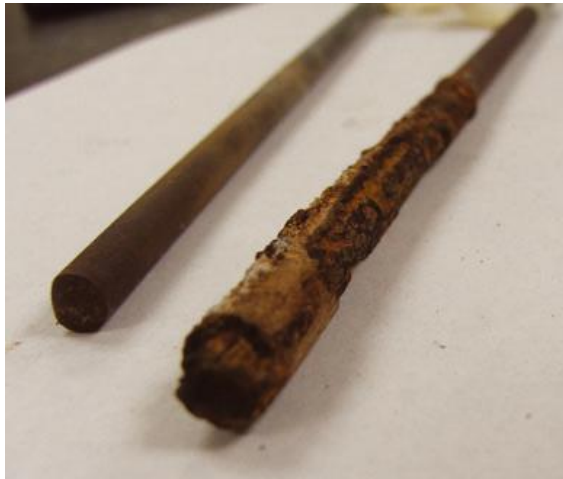
Disconnection of the rebar inside the cathodically protected concrete structures leads to rebar corrosion at the anodic areas of the disconnected rebar.

a - Continuous (left) and discontinuous reinforcing bars;
b - cracked specimen with discontinuous reinforcing bar after 2-month test at current density less than 1 A/m^2

Sometimes a part of reinforcing bars (at the areas contacting with aggressive environment) is made of stainless steels 304 and 316. A direct contact between stainless steel and carbon steel bars is excluded in these structures, in order to prevent galvanic effect. However, the structure with discontinuous rebar is susceptible to stray current attack. Reinforcing bars of stainless steel undergo cracking even earlier than the specimens reinforced with bars of carbon steel. So, when hazard of stray current attack exist, such combination of rebar cannot be used.

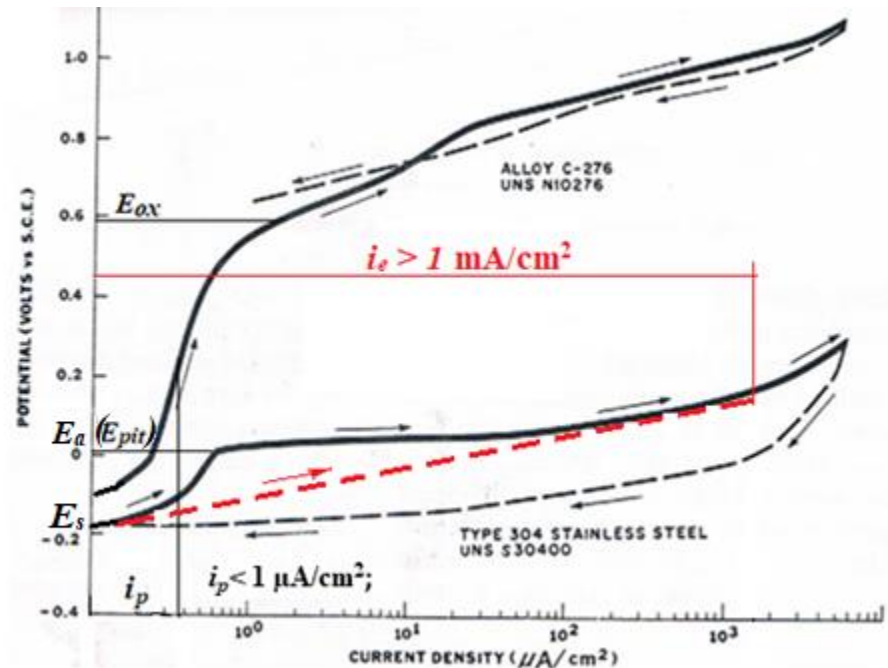
Cyclic potentiodynamic polarization curves on SS 304 and Hastelloy Alloy C-276 (Standard G-61-86) in 3.56% NaCl solution at temperature 25°C (representative)

Factors shifting pitting potential to the negative: activators (Cl⁻), temperature, surface defects (scratches), crevices, biofilm;

Factors shifting corrosion potential to the positive: stirring, oxidizers, contact with a more positive metal, external anodic current.

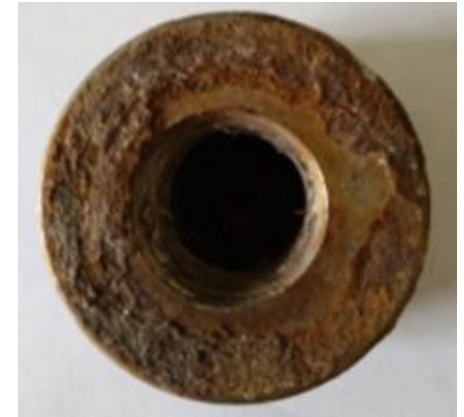
b - Electric field from the protected nozzle

Stray current corrosion of bottom part of a bush made of super-duplex
