Failure analysis of DC motor-brushes

Ruth Avivi M.Sc.

IAI – Israel Aerospace Industries LTD.
Systems, Missiles & Space Group, MBT Missiles division
Phone: 972-58-6109588, e-mail: Ruavivi@iai.co.il

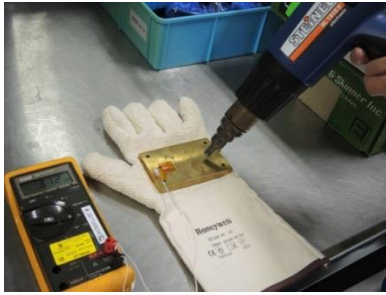
An experiment which was carried out on a single motor-brush sample (Figure 4) revealed that the melting point of the soldering material was about 190 °C – at this temperature range, bubbles started to appear between the string and the brush.

Figure 4: *Measuring soldering material's melting point*

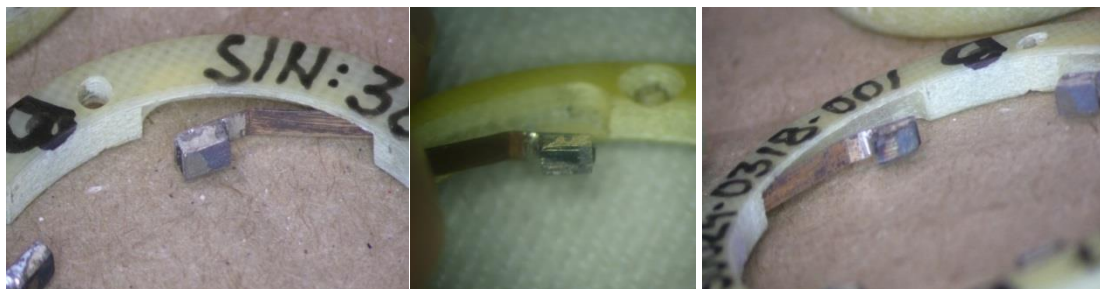
At this point we decided to visually examine brand-new brushes and their brush-rings (figure 6 - a, b and c). We found out that brushes on the same brush-ring each had its own different dimensions, some varied significantly (about 30% surface area differences).

Since current density is calculated as a function of supplied current divided by brushes' dimensions, the small-size brushes will have higher current densities and as the area of current flow decreases, resistance increases. As a result, joule heat and contact temperature both increase. Therefore, the current supply increases the temperature of the contact surface by electrical resistance heat, which increases wear.

Figure 6: a, b and c (left to right): *Results of visual examination of brand-new brushes: Different brush dimensions and uneven contact surface.*

Additionally, we discovered that the contact-surface of the brushes was very rough and uneven. Since the entire commutating process between the brush and the commutator is based on points of contact** (see figure 7), it is important that the contact spots will be evenly distributed on the surface of the brush to maintain brush balance and avoid damage to the commutator's surface as seen in figure 8.
